Chapter 1 BACKGROUND

1.1 INTRODUCTION

A fire occurred on the night of Feb. 20, 2003, in The Station nightclub at 211 Cowesett Avenue, West Warwick, Rhode Island. A band that was performing that night, during its performance, used pyrotechnics that ignited foam insulation lining the walls and ceiling of the platform being used as a stage. The fire spread quickly along the ceiling area over the dance floor. Smoke was visible in the exit doorways in a little more than one minute, and flames were observed breaking through a portion of the roof in less than five minutes. Egress from the nightclub was hampered by crowding at the main entrance to the building. One hundred people lost their lives in the fire.

The National Institute of Standards and Technology (NIST), under the authority of the National Construction Safety Team (NCST) Act [1], established a National Construction Safety Team (Team) on Feb. 27, 2003, to determine the likely technical causes of the building failure that led to the high number of casualties in that fire. The investigation included the following tasks:

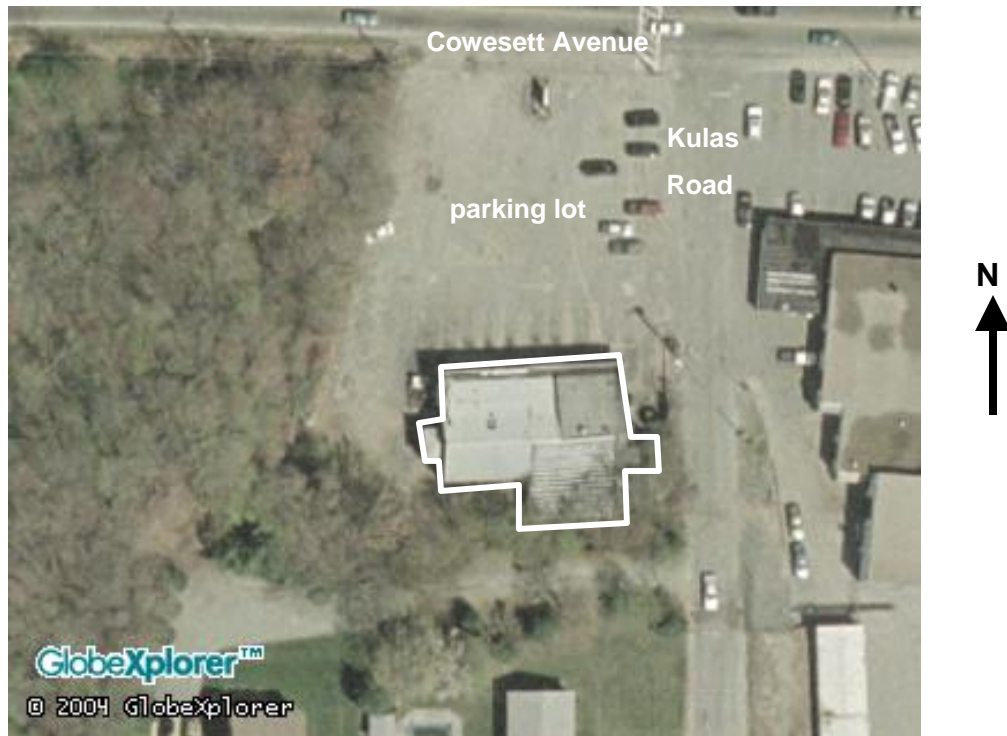
Figure 1-1. General orientation of building and site [2]

The Station nightclub was located at 211 Cowesett Avenue, West Warwick, Rhode Island. It was a single-story wood frame building with a footprint of about 412 m² (4484 ft²) and a small basement under the main bar room. Figure 1-1 is a photograph of the building on its lot. The north-facing front door of the nightclub was set back about 42 m (140 ft) from Cowesett Avenue, a three-lane, two way street that runs east-to-west. Kulas Road is two lanes wide and runs along the east side of the building, about 10 m (33 ft) east of the side bar exit. There was no direct street access to the building from either the west or south sides. Parking for over 100 cars was provided in the front and to the west side of the building.

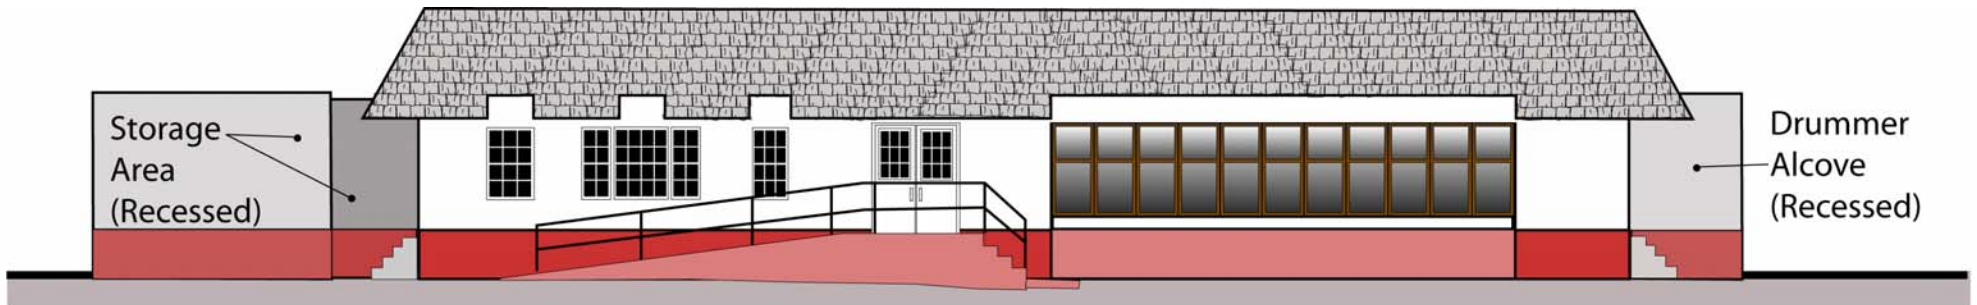
Figure 1-3. Sketch of the north side of The Station nightclub locating the main entrance, front stairway/ramp, windows in the main bar area (left), sunroom/pool room (right), and exit stairs from the east and west sides

Figure 1-3 is a sketch showing the north side of the building approximately as it looked on February 20, 2003. Note the windows on the left which are in the main bar area, the windows on the right in the sunroom/poolroom, the ramp and stairs leading from the main entrance in front, and the stairways leading from side exits on the west and east of the building. Inside the double doors of the main entrance is a vestibule with a single doorway. Figures 1-4a and 1-4b are photographs of the north side and north west corner of the building as they looked within a year or two of the February 20, 2003 fire. The external walls were primarily covered with painted wood shingles or panels above a concrete foundation. The roof was flat with a wood shingle façade along the front and sides, as seen in the photographs.

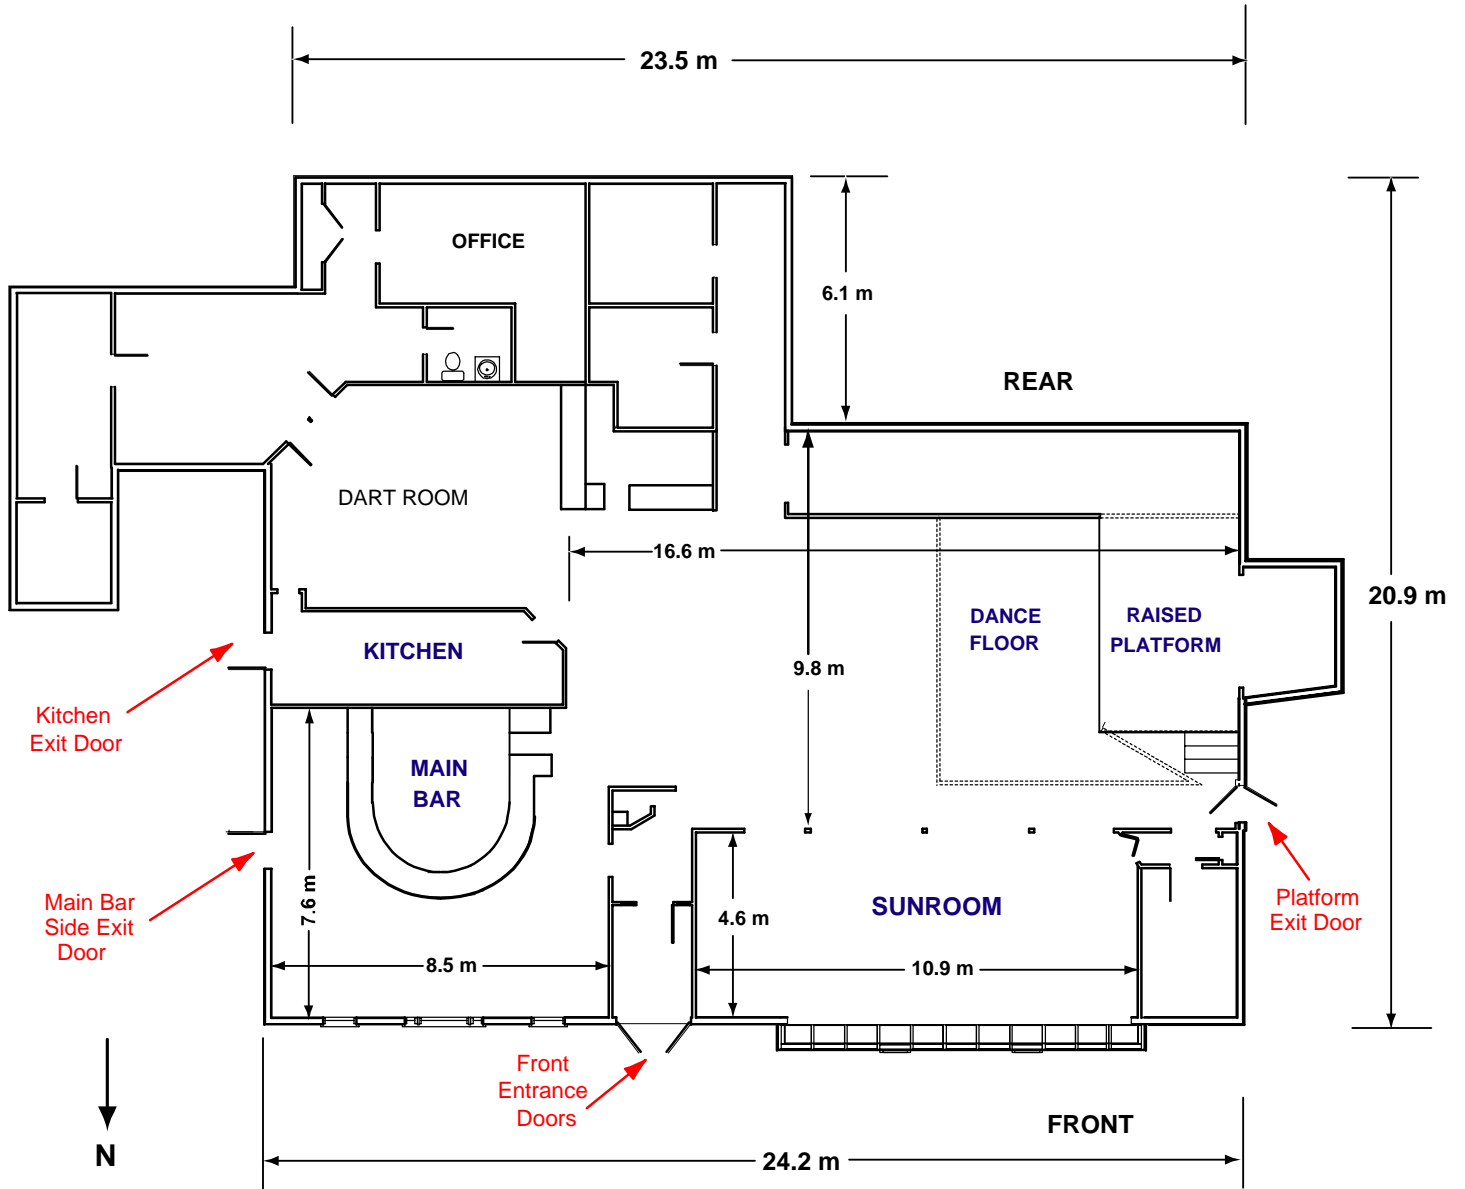
Figure 1-5. Plan view of The Station showing different rooms and exits.

Figure 1-5 shows a plan view of the nightclub floor, a composite from multiple sources of information obtained during the investigation. Entering from the front through the double doors would have brought one into a short entrance hall with a single door at the far end that led to the ticket-taker area. To the right of the ticket taker was an assembly area containing the dance floor, sunroom (or poolroom), elevated dining area, and a platform (imprecisely referred to as a stage) with the drummer's alcove. A dressing room was situated in the northwest corner and an exit to the outside was located between the platform and dressing room. Except for the front of the sunroom, which was composed of darkened glass windows, there were no other windows in the right half of the nightclub.

Turning left at the ticket-taker area would have brought one into the main (or horseshoe) bar room. An exit to the outside was located on the far left wall. There were no windows on that wall but windows lined most of the front of the main bar room.

The kitchen separated the main bar room from a smaller assembly area (or dart room) and back bar. There was one door to the outside from within the kitchen. A storage area, office, and restrooms were located in the back of the nightclub. There were no additional exits leading directly to the outside from these rooms; any windows or exits that had been installed were covered with bars or paneling.

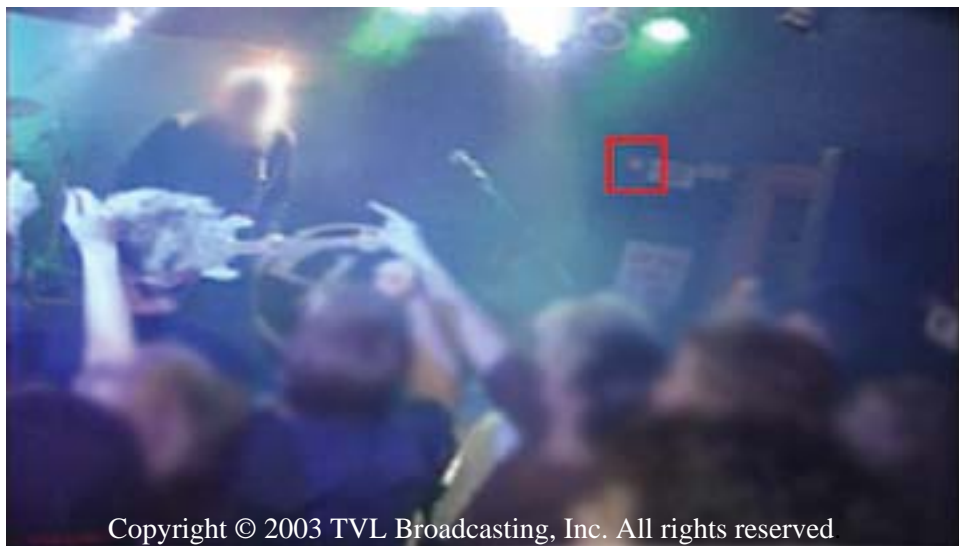
Figure 1-6a. View of inside of nightclub showing exit sign above door near platform [4]

Figures 1-6a and 1-6b show different views inside the nightclub, highlighting the exit doors next to the platform and the exit from the main bar area.
